**NAVAL
POSTGRADUATE
SCHOOL**

THESIS

**ANALYSIS OF THE FAILURE OF A VACUUM SPIN-PIT
DRIVE TURBINE SPINDLE SHAFT**

September 2005

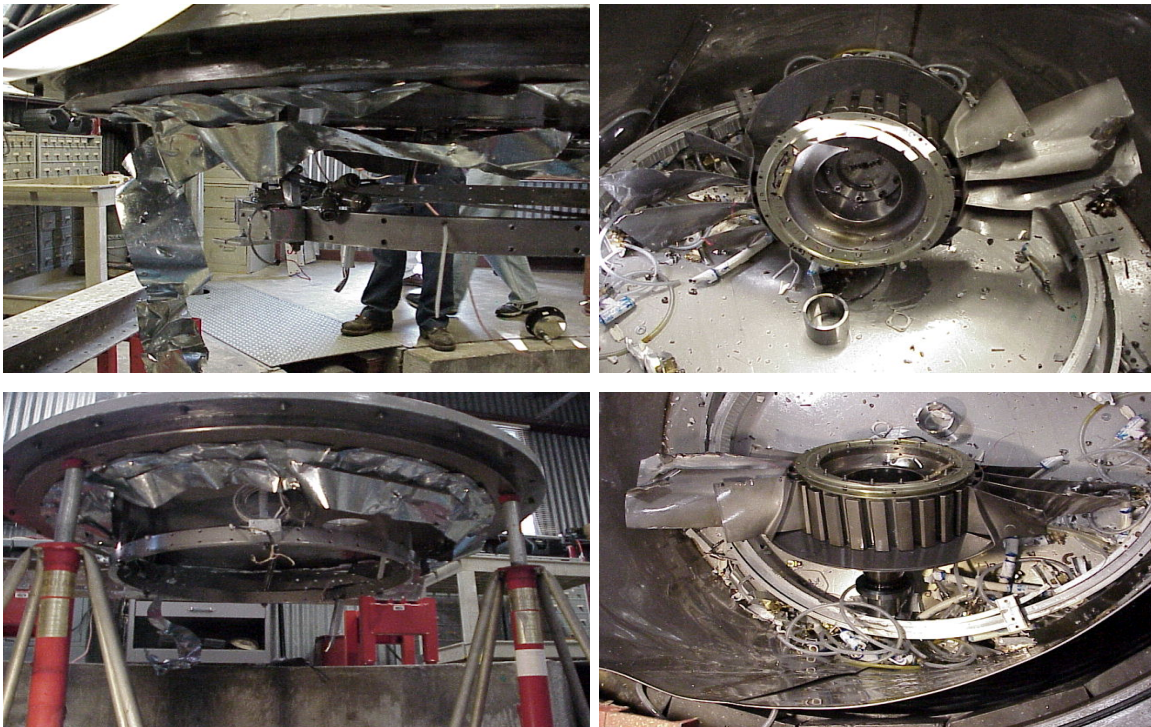
7600 RPM. However, during this initial run, while checks were being made of the instrumentation, the RPM drifted up to around 1600 RPM. Once the operator realized the upward drift, the speed was immediately increased to 2000 RPM. Once all checks were completed, the RPM was then steadily increased towards the target speed. After about 15-18 minutes of operation, and at about 2500 RPM, the spindle shaft failed, dropping the rotor into the spin pit. There was extensive damage done within the pit. All instrumentation and the oil-excitation system were destroyed. However, the pit itself, and the stainless steel liner which collected the injected oil, were intact.

Figure 6. Images of Failure Aftermath

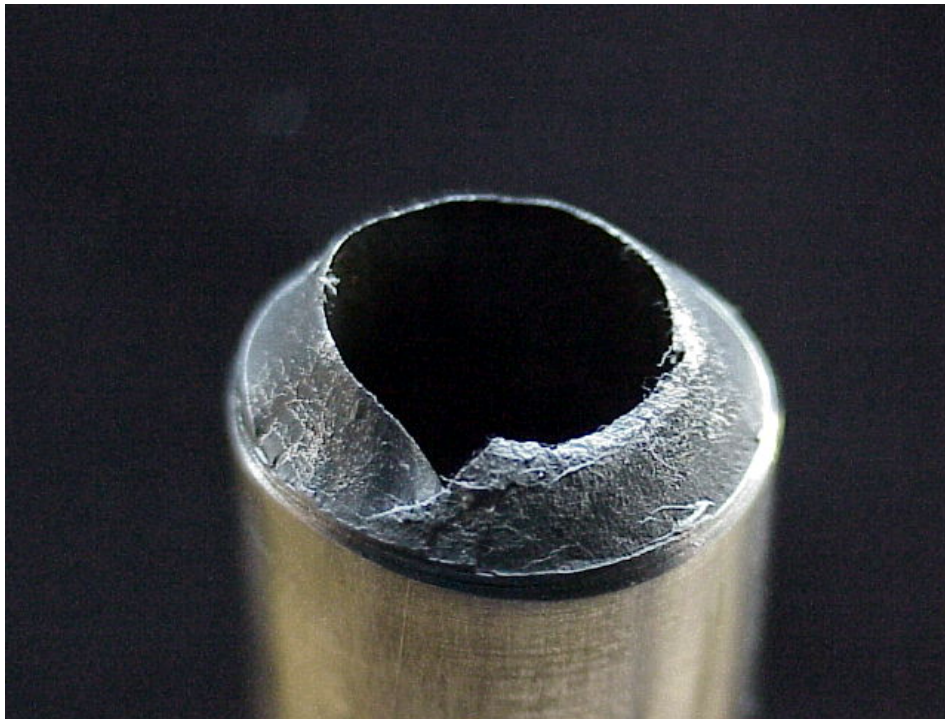
The shaft was removed from the spin pit and care was taken to not damage the fracture surfaces on the spindle. Photographs were taken, as shown in Figures 9-13. A cursory visual analysis of the failed shaft and photographs revealed extensive plastic deformation and a generally dull, fibrous surface texture, - two observations that are strongly indicative of ductile failure by microvoid formation and coalescence. Also, the failure plane was approximately 45 degrees to the longitudinal axis, - suggestive of a ductile fracture in tension. The elongation and deformation was most noticeable on the outer diameter of the shaft whereas the inner diameter remained relatively unchanged.

Figure 9. Upper Spindle Fracture Surface

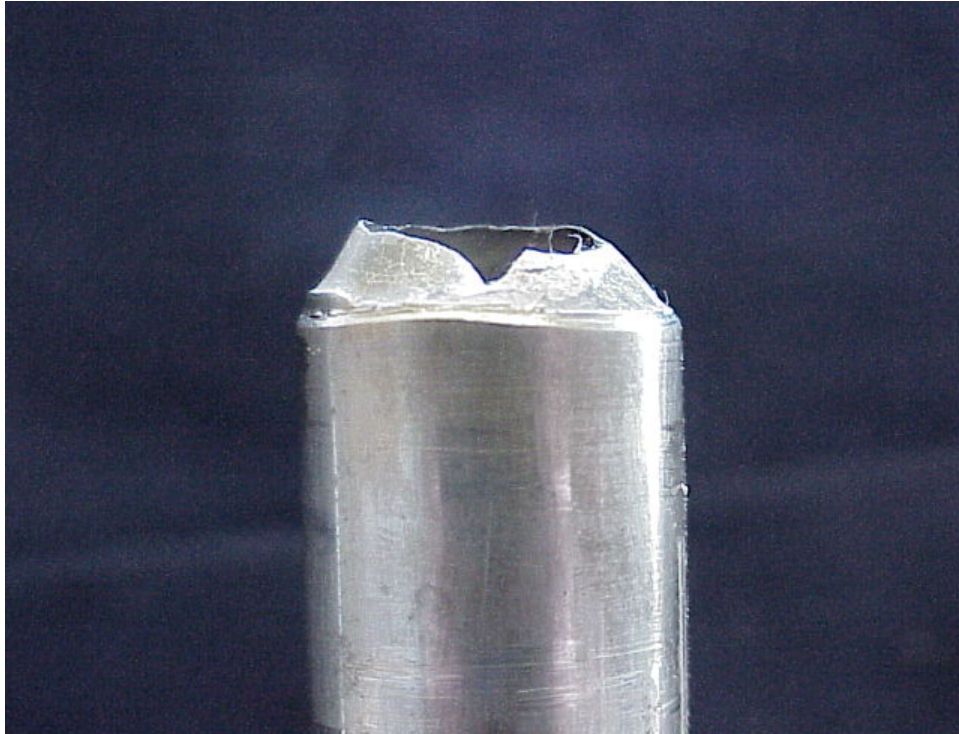
Figure 10. Upper Spindle Fracture Surface (Side View)

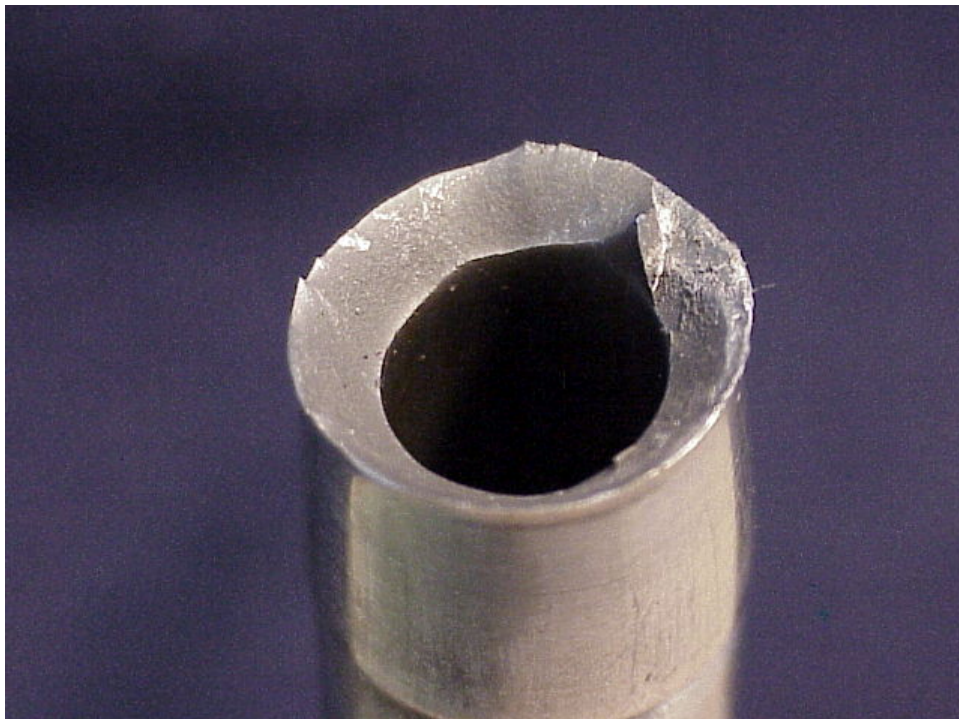
Figure 11. Lower Spindle Fracture Surface

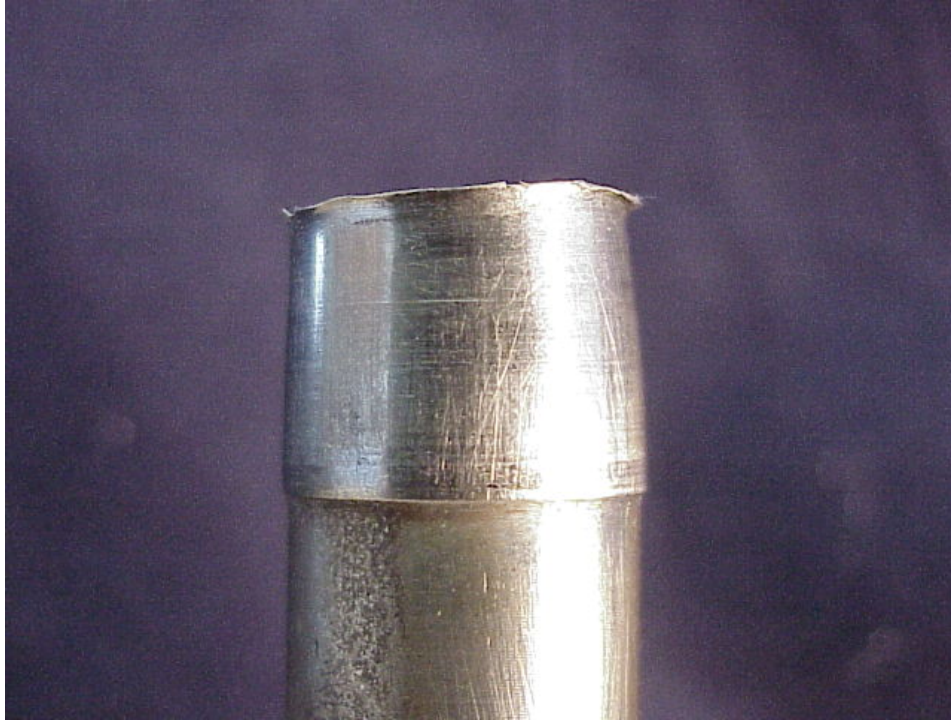
Figure 12. Lower Spindle Fracture Surface (Side View)

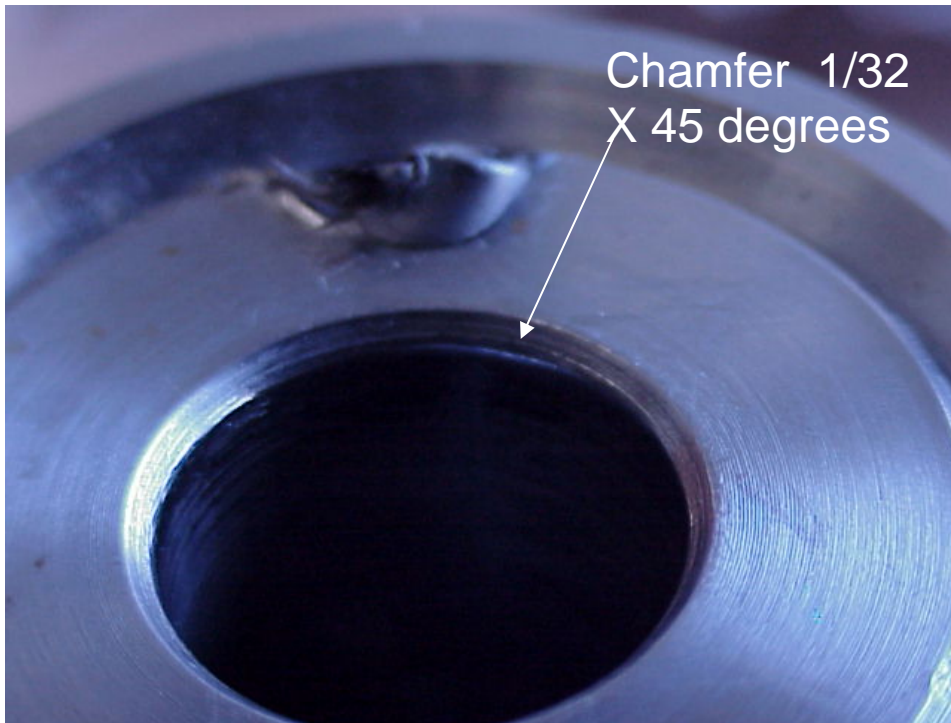
Figure 13. Spindle/Adapter Interface with 45° Chamfer

Figure 13 shows a picture of the adapter/spindle interface, the location where the fracture occurred. One interesting aspect is the 45 degree chamfer at the plane of fracture. This (sharp) chamfer would put a stress raiser on the outer diameter of the shaft. Also, the adapter connected to the spindle shaft through a pinned connection approximately 3 inches below this interface. Because the shaft transmitted torque to the adapter through the double pinned threaded connection, it is possible that a phase shift could have occurred between the shaft and adapter. This shift would have put a torsional stress on the shaft. Both the upper spindle fracture and the adapter interface had a shiny, worn region on the outer and inner diameters, respectively, at the plane of fracture. This shiny, worn region likely would be caused from constant friction and angular movement between the shaft and adapter at the chamfer.

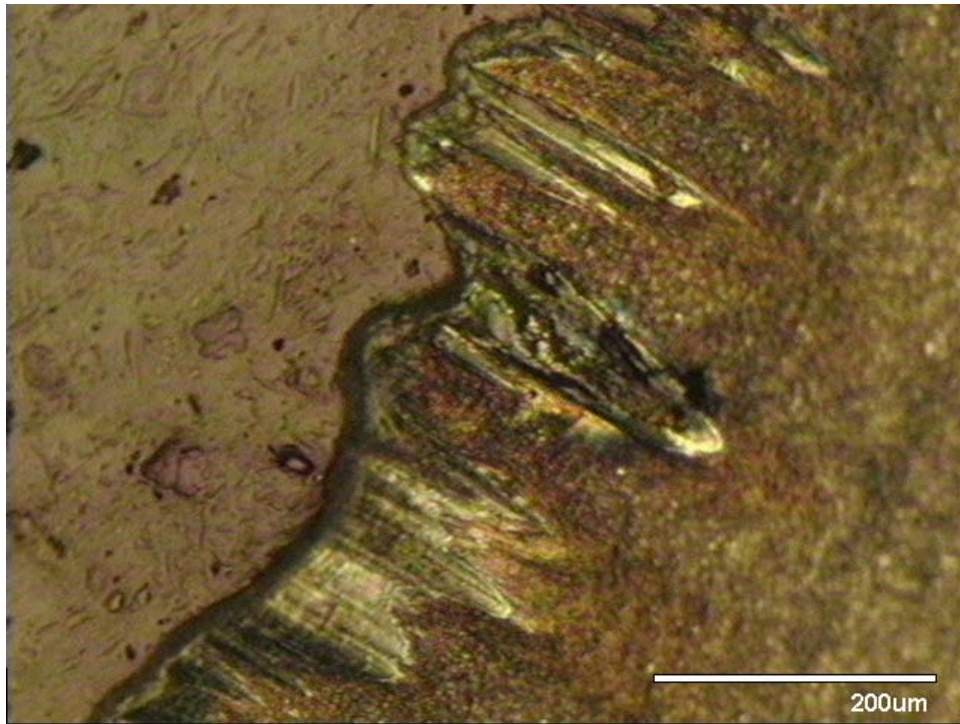
Images taken at 290 \times magnification (Figures 15 and 16) provided little conclusive evidence as to whether or not the material was potentially flawed. The images taken at this low magnification did provide an exceptional macroscopic image of the fracture surface perimeter and documented the steel's heat treatment.

Figure 16. Perimeter of Fracture Region (290×)

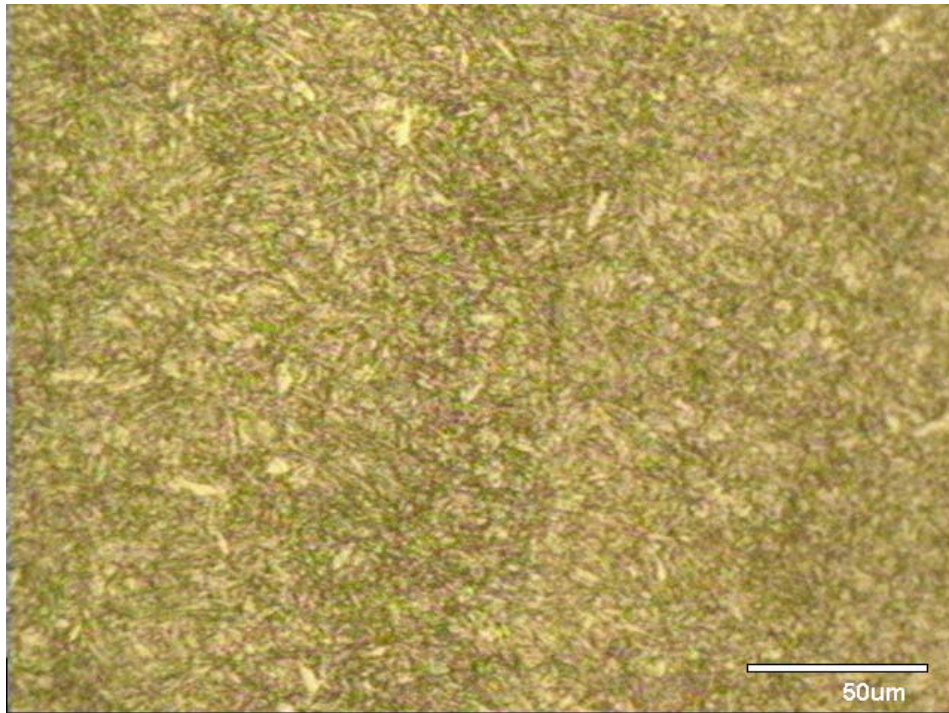
Under 750× magnification, shown in Figure 18, the microstructure could be confidently identified as tempered martensite. The martensite formed during quenching as carbon was trapped in the lattice as γ austenite transformed to distorted α ferrite. Very fine, needle-like regims of martensite formed with the austenite. Tempered carbides formed as precipitates when the martensite was tempered at elevated temperatures and the carbon was allowed to thermally diffuse out of the martensite's octahedral interstitial sites.

Figure 18. Optical Photomicrograph (750×)

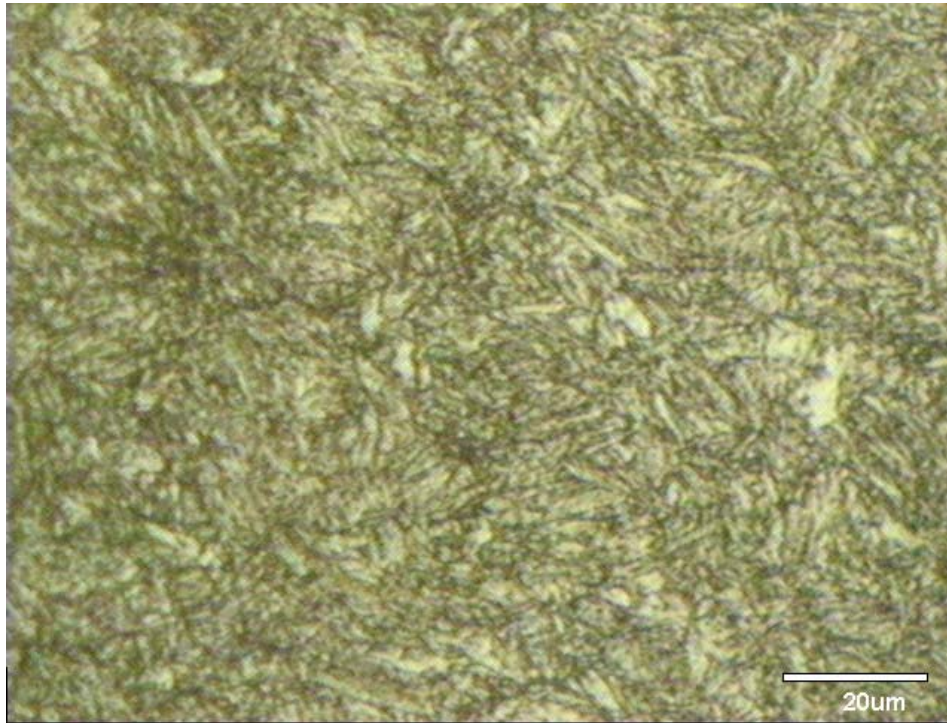
At 1500× magnification, shown in Figure 19, the microstructure became still better defined and it was easier to identify the tempered martensite. The cementite particles were very fine. Nevertheless, the needle-like

appearance of the martensite was apparent. This high tempering would result in larger grains, improved ductility and toughness, but substantial loss in strength and hardness.

Figure 19. Optical Photomicrograph (1500×)

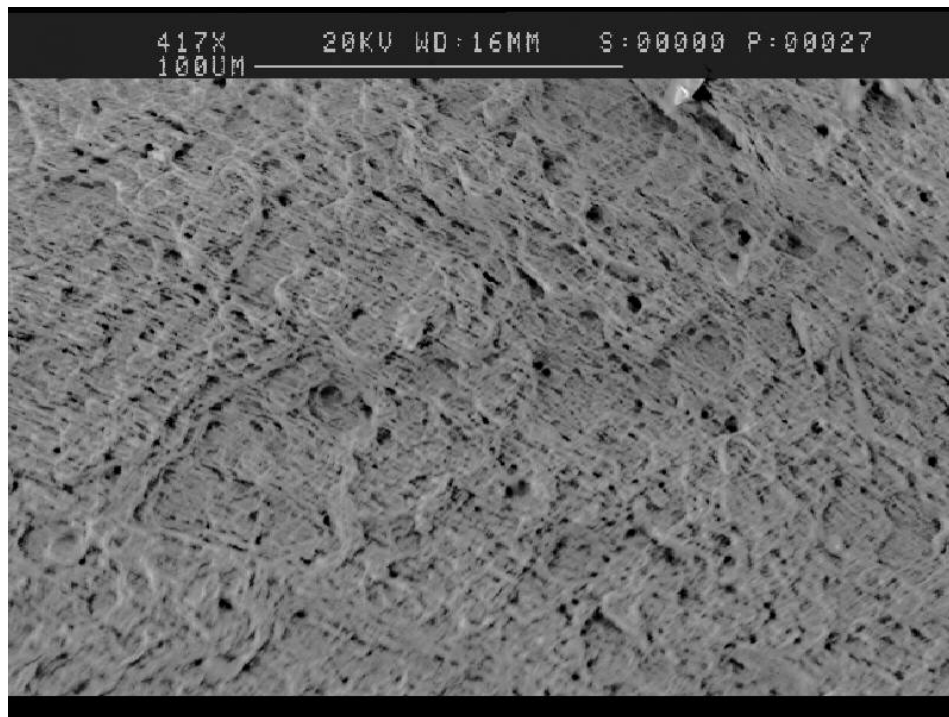
Figure 21. SEM Fractograph 1

Figure 21 shows the first SEM fractograph that was taken near the middle of the failure region. This photo shows a clear case of ductile fracture through microvoid formation and coalescence. The fibrous texture appearance

and microspheres indicate that deformation of the grains and then failure occurred along the grain boundaries. Essentially, the grains were stretched and "plucked" apart leaving spherical voids where the grains from the upper fracture region separated from the lower fracture region.

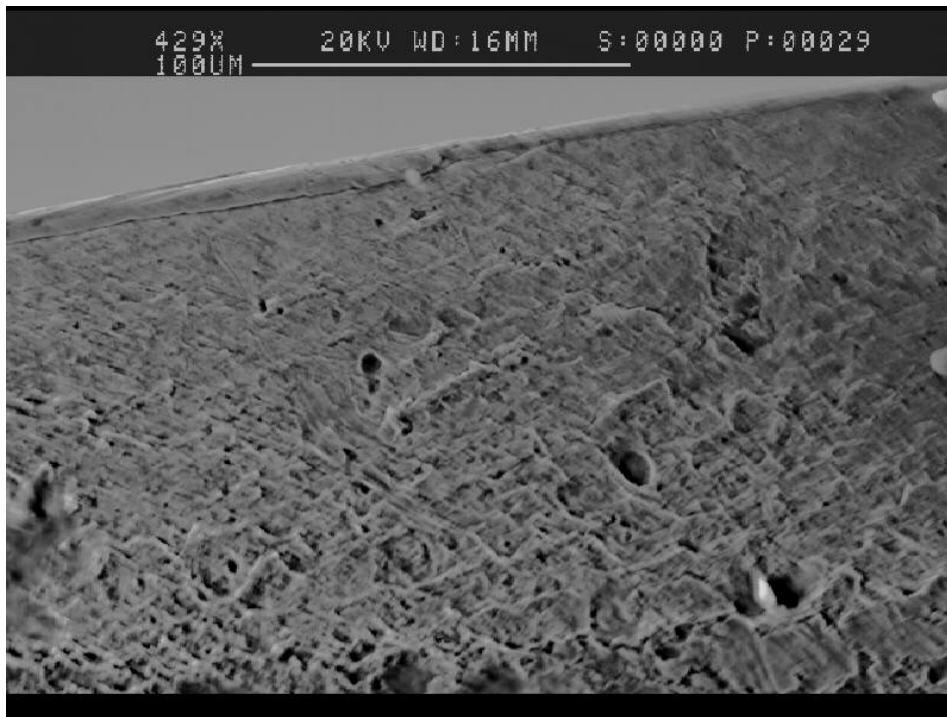
Figure 22. SEM Fractograph 2

Figure 22 shows the second SEM fractograph that was taken towards the outer diameter, on the shear lip, of the spindle shaft failure. In this view, the spherical microvoids begin to become elongated and point towards the origin of the failure. Also, the highly fibrous texture of the surface begins to fade when approaching the outer edge of the shaft. This is due to the transition between the instantaneous and an apparent fatigue zone. Towards the outer diameter a fatigue zone is seemingly present with a

flatter texture and striations are present. These striations are indicative of the cyclic crack propagation.

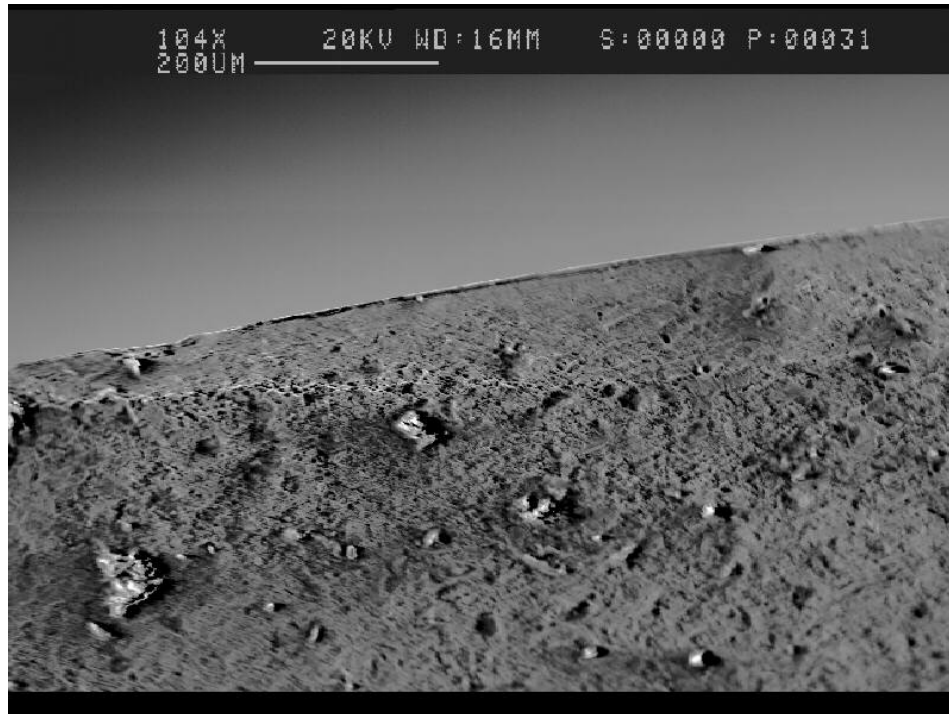
Figure 23. SEM Fractograph 3

Because the elongation of the microvoids pointed towards the outer diameter of the shaft and there was an apparent fatigue zone, another SEM photo was taken around the perimeter. The third photo was taken at a lower magnification in order to see if there was a more pronounced transition between the two zones. Figure 23 shows a different portion of the outer perimeter of the spindle and an even clearer line between the instantaneous zone and fatigue zone. There is a clear difference in surface texture and a solid "ridge-like" line separating the two zones.

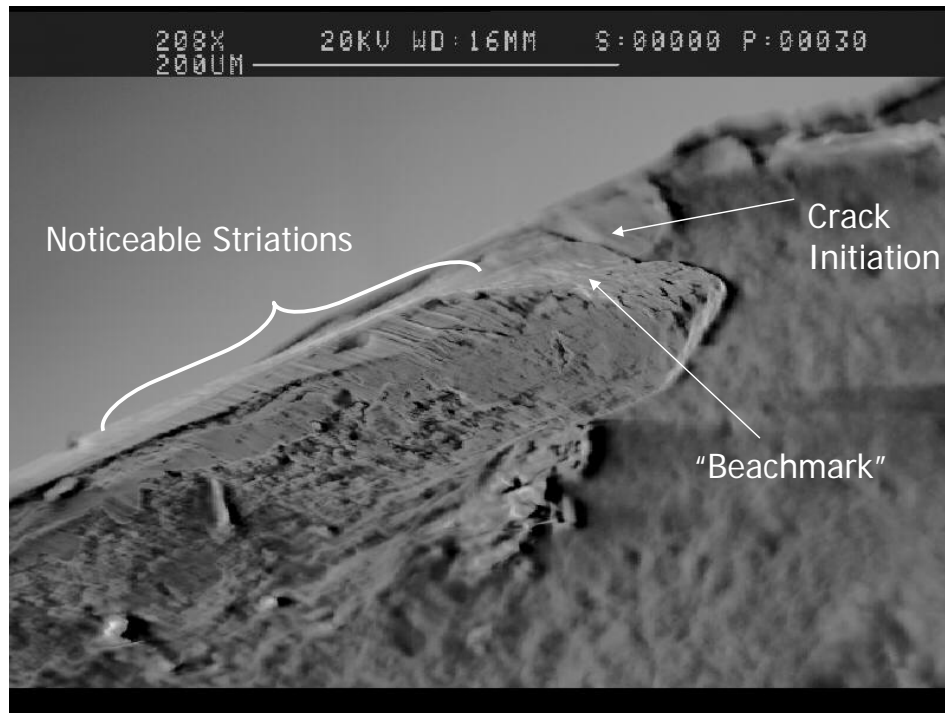
Figure 24. SEM Fractograph 4 (Crack Initiation)

Continuing around the perimeter, an image of the crack initiation point was captured. Figure 24 clearly shows the point of crack initiation. There is a large beachmark present which indicates the large initial propagation of the crack. The noticeable striations indicate the cyclic propagation of the crack that occurred during each spin-up of the spin pit.

These four SEM fractographs suggest failure by two distinct modes: (1) low cycle, high-stress fatigue (LCF) and (2) ductile failure through microvoid formation and coalescence. The latter mode is indicated by the presence of numerous spherical, equiaxed microvoids ranging from approximately 1-3 μm , as well as generally fibrous texture of the fracture surface. Fatigue is also strongly

indicated by the presence of striations. Also, the size of the fatigue zone compared to the instantaneous zone is relatively small, less than 10% of entire failure area, which supports the notion of high stress, low cycle fatigue.

In the interest of preventing this type of failure in future tests, some recommendations for changes to the system and its operation are made. First, although the standard 1000 RPM dwell speed is away from bending and torsional modes, the ARMD program does not have the ability to couple bending and torsion together in a single analysis. Therefore, because the most harmful resonant modes are at lower operating speeds, it is recommended that all system checks be performed before start up, or expedited as much as possible, and speed quickly increased to the target operating speed. Also, an increase in thickness of the spindle shaft is recommended. An increase in thickness will decrease the stresses on the outer diameter of the shaft. Also, by increasing the thickness, critical crack depth will increase and crack presence should be easier to identify. With this increase, it is also recommended that a visual inspection of the system be performed after every test. Special attention should be given to the spindle shaft, thoroughly looking for cracks and deformation. At the spindle/adaptor interface, it is recommended that the 45 degree chamfer be changed to a radiused chamfer in order to alleviate the stresses at the plane where the fracture took place. Also, proximity probes should be placed above the interface (on the spindle shaft) and below the interface (on the adaptor). Two probes should be placed at each location and should be set 90 degrees apart. They should then be monitored in order to determine if there is a substantial phase shift occurring between the spindle and adaptor configuration. Finally, it is recommended that staff at the Turbopropulsion Laboratory take a training course or

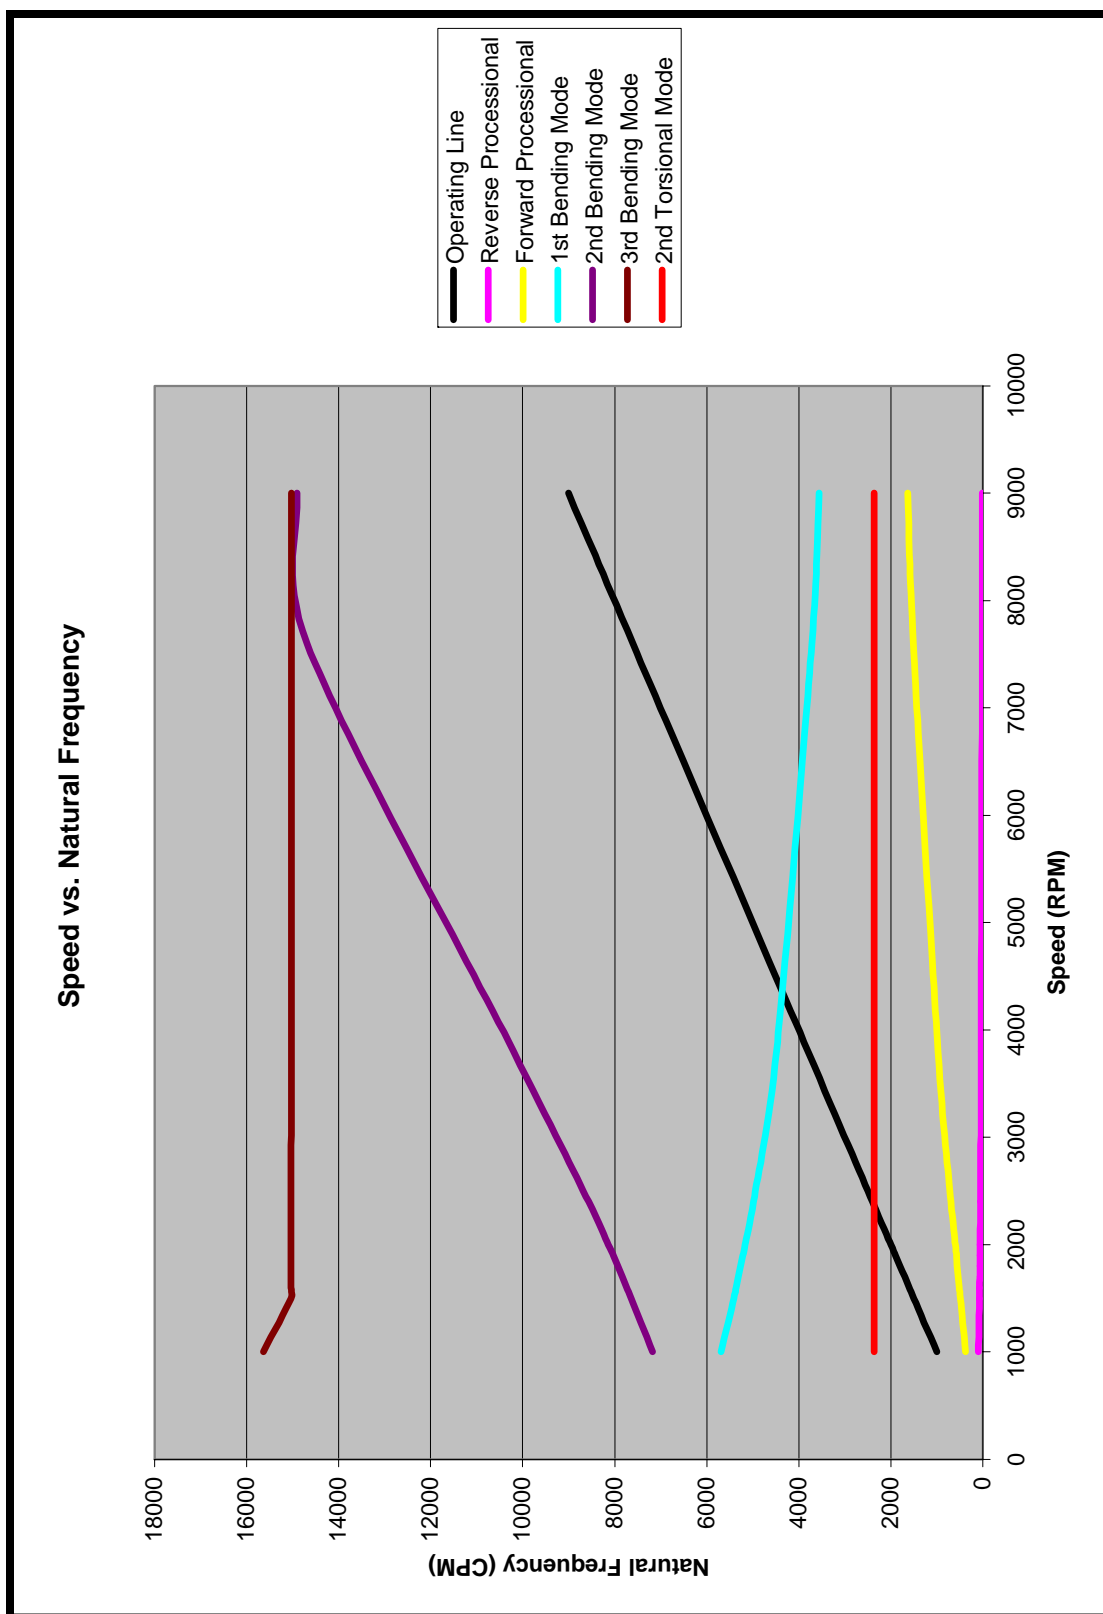
Figure 28. Campbell Diagram

From the Campbell diagram it is clear that the only bending mode that could possibly present a problem is the 1st bending mode. However, this mode intersects the operating line (1/rev) at approximately 4300 RPM, which is outside the normal operating speed range. As long as the speed of the system never dwelled at this speed, no damage would have occurred due to 1st bending.

The torsional vibration analysis yielded two torsional modes that existed within the operating speeds. The first torsional mode is present at an insignificantly low speed of approximately 15 RPM. However, the second torsional mode is located at approximately 2350 RPM. This mode is close to the speed of 2500 RPM where failure occurred.
